Emergency Vehicle Access Craig Bay

Prepared for Craig Bay Community Lands Committee

March 31, 2011

Submitted by Don Saigle - Director

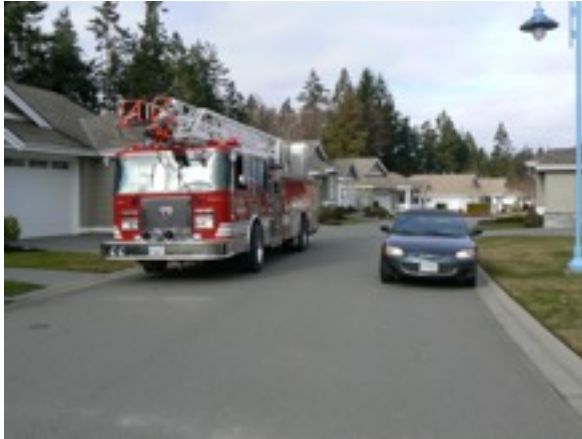
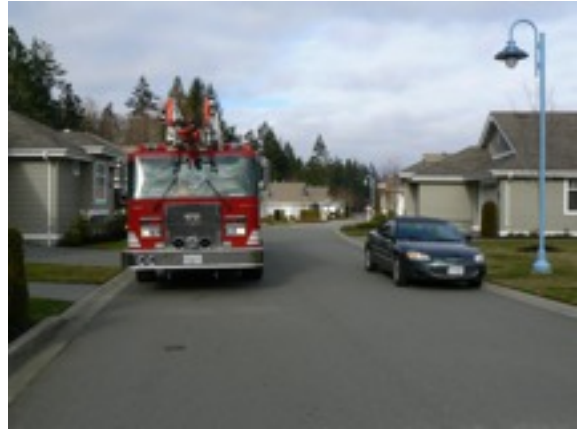
Regardless of some variation in road widths in the community, the fire truck was able to freely negotiate our roads with a vehicle parked on one side. In the case of Cape Cod, there was a clear 8 feet between the fire truck and parked car. While less clearance on Saltspring Pl. and Gambier Pl., passage would still be possible.

Facing East along Cape Cod Dr. - February 10, 2011

- 1) The road system in Craig Bay can be improved by limiting or restricting parking in keeping with accepted standards. These include:
 - **Road side parking:** Emergency vehicles are large and need adequate room to operate. A 12 ft. wide lane of unobstructed travel is viewed as an acceptable standard. This can be provided by limited parking to a single side of the road.

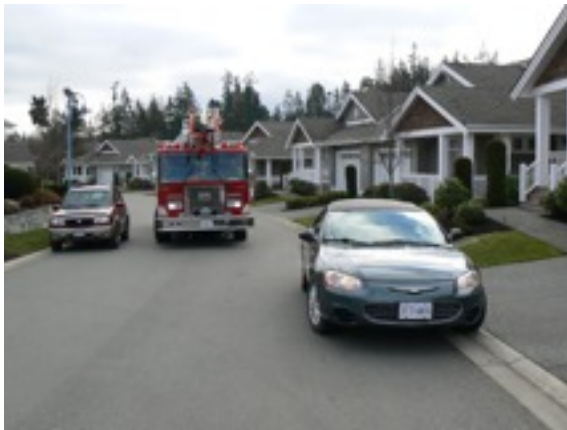
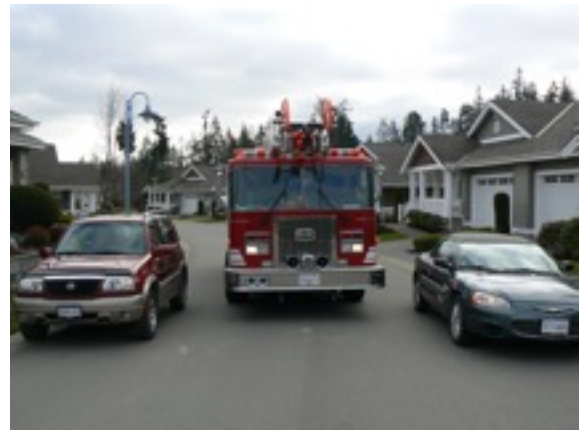
When faced with vehicles parked on both sides of the road, its speed and maneuverability decreased significantly. On Britannia Dr., there was only 3 feet of clearance between the sides of the fire truck and the parked cars.

Facing West along Britannia Dr. - February 10, 2011

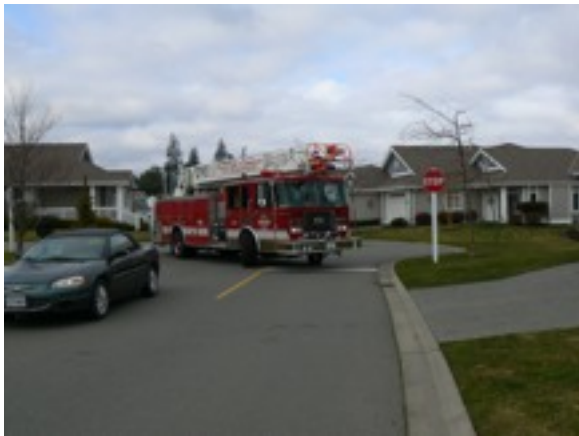
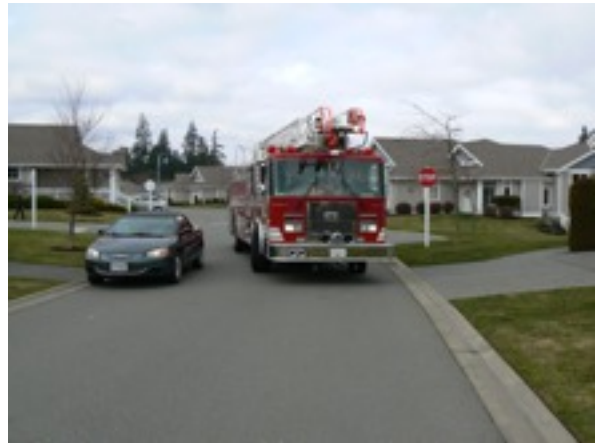
When making a right hand turn at an intersection, the fire truck is required to make as wide a turn possible and enter the on-coming lane. If a second vehicle were parked in the on-coming lane, access would be blocked.

Turning East onto Saturna Dr. from Galiano Dr. - February 10, 2011

- **Intersection set-backs:** Emergency vehicles are required to make wide turns at intersections, often entering into on-coming traffic lanes. The establishment of no parking zones extending 15 ft. along either side of the receiving roads will provide adequate room. This is also viewed as an acceptable standard. to provide this.

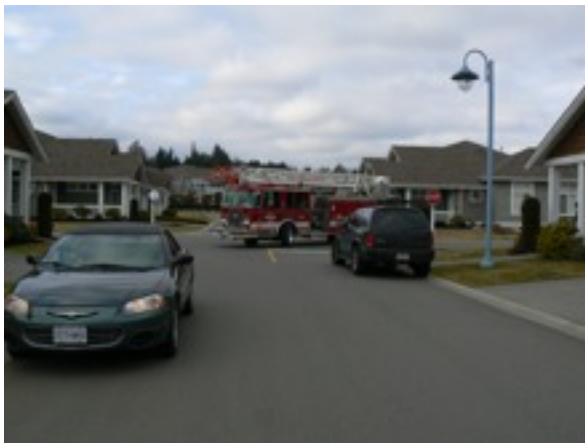
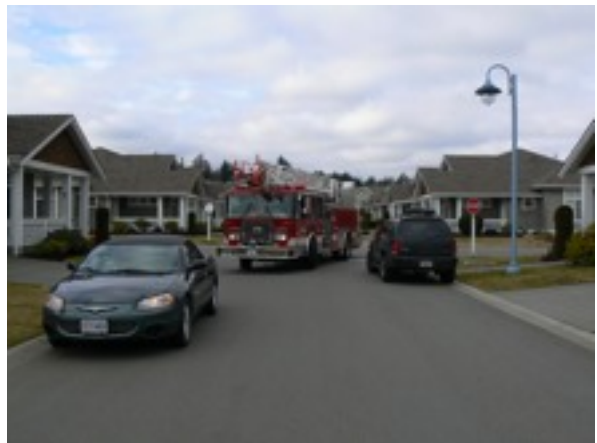
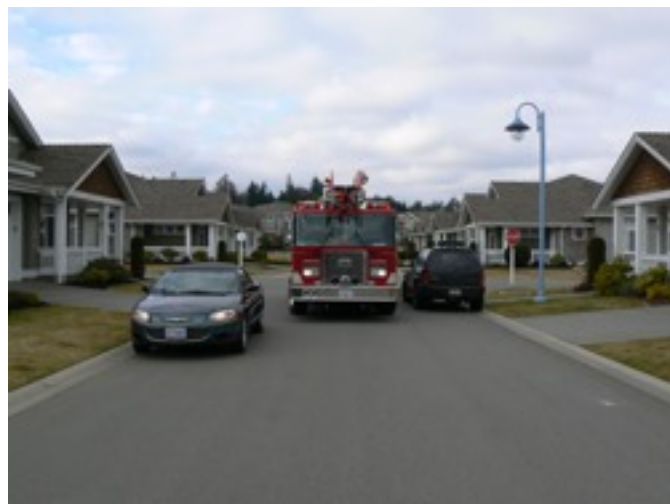
When making a left hand turn, vehicles parked along the road become problematic for safe negotiation of the turn. Again, depending on vehicle placement, access could be blocked.

Turning East from Pender Dr. on to Madeira Ave. - February 10, 2011

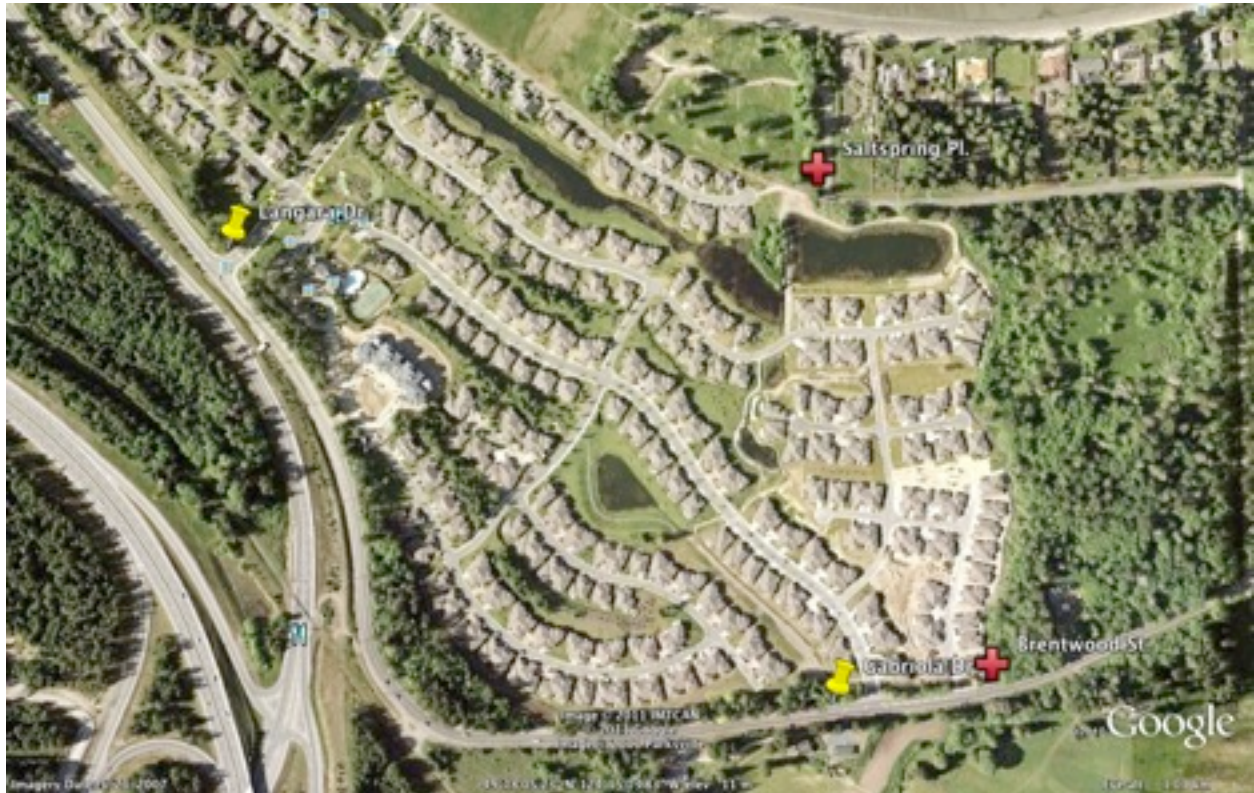
There are two primary roads into Craig Bay. Langara Dr. and Gabriola Dr. (yellow pins). Both intersect with Northwest Bay Rd. and are accessible from the West and East.

Secondary or emergency access points (red crosses) are located at the intersections of Brentwood St and Northwest Bay Rd. and Saltspring Pl. and Bay Rd. The latter is only accessible from the East. The entrances are signed and gated. The gates are pinned to keep them in the closed position and if properly maintained, can be swung open as required.

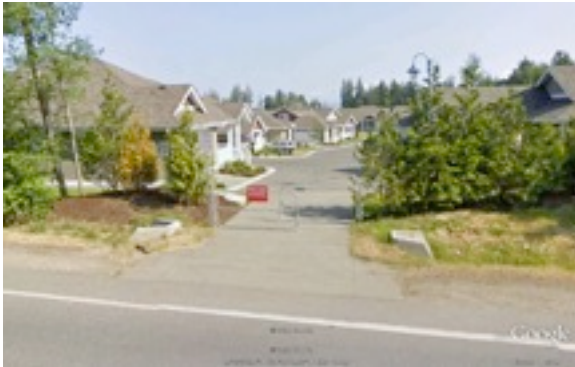
Looking North along Brentwood St. from Northwest Bay Rd.

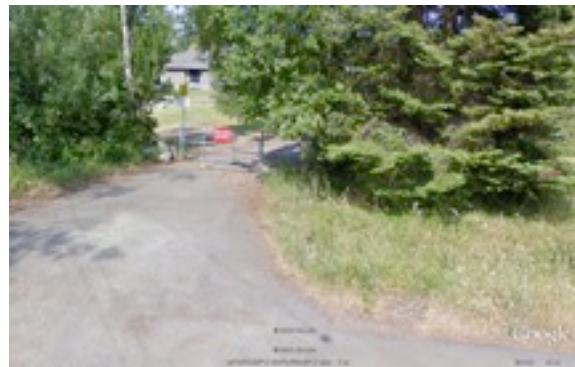
Looking West into Saltspring Pl. entrance from Bay Rd.

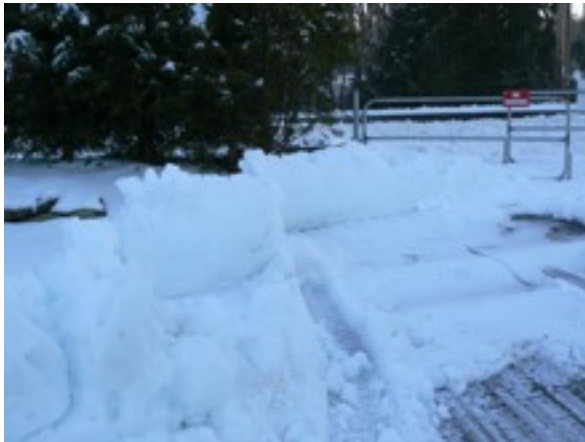
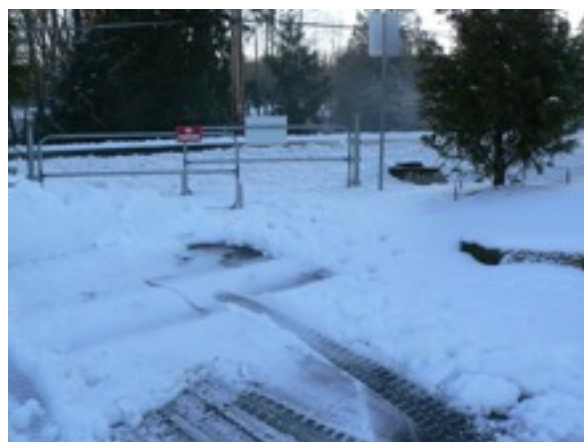
The emergency access routes require additional attention during snow falls. During the 2008/09 and 2010/11 winter seasons, both gates were blocked and impassable. The high moisture content and sub zero temperatures turned the snow piles in blocks of ice.

Looking towards Northwest Bay Rd. from Brentwood St. - January 09, 2011

- 2) The road system in Craig Bay can be improved once unimpeded access to the 2 emergency routes can be ensured and maintained. A clear statement of maintenance expectations, co-operation and monitoring, especially during the winter months will assist in reaching this goal.

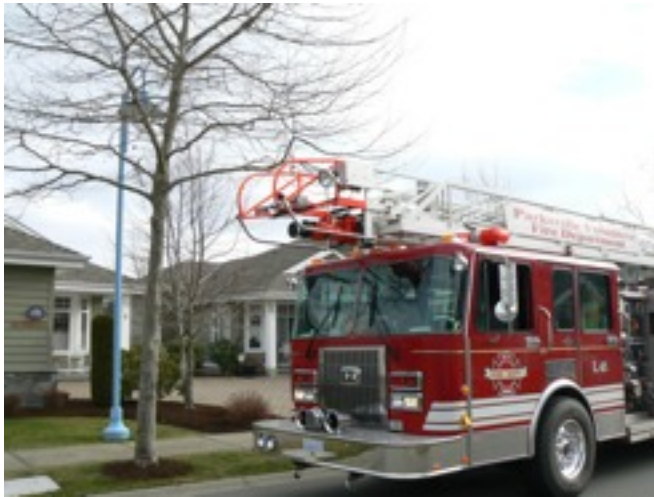
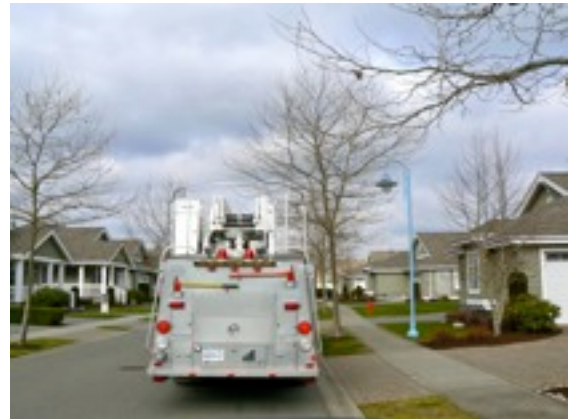
- 1) branches hang into the travelled portion of the road risk making contact with the sides of the vehicle and
- 2) low hanging branches risk making contact with the top of passing vehicles.
- 3) trees height and width are such as to block the illumination from the street lights.

The encroachment of branches forces vehicles to move towards the center of the road to avoid damage caused by the branches on the side and/or top of the vehicle. In the case of emergency vehicles, this contact may damage rescue apparatus. Working towards pruning standards would reduce or eliminate the encroachment of tree limbs relative to the road surface and street lights.

Facing West along Gabriola Dr. - February 10, 2011

- 1) Adopting a community standard to ensure overhanging tree branches do not interfere with vehicles will improve use of the road system. Overhanging branches should not come in contact with vehicle traffic and trimmed to a minimum height of 12 ft. measured from the road surface. Tree height and shaping should provide for maximum illumination by street lights.
